**CUT PROGRESSION DURING DYNAMOMETER
TESTING OF FOREIGN OBJECT DAMAGED TYPE
VII EXTRA HIGH PRESSURE AIRCRAFT TIRES
SAE PAPER 912155**

SEPTEMBER 1991

FINAL REPORT FOR 03/15/1984 – 06/15/1991

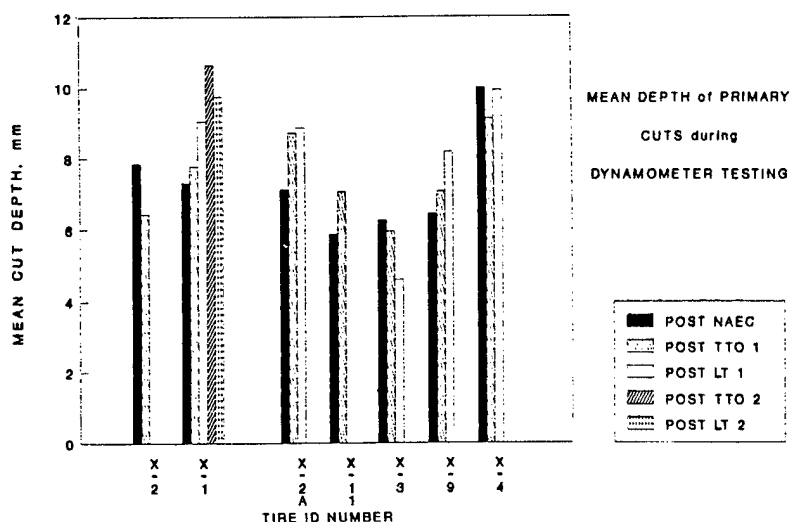
FIGURE 16: DEPTH CHANGES during TEST Recapped Tires

INDIVIDUAL CONDITION WITH TESTING - Changes in the mean cut depth of primary cuts of seven tires are presented in Figure 16. Damage is unpredictable. An increase or decrease in mean depth on one segment might be followed by the opposite after the next segment. The changes include the cut becoming shallower, deeper, or closing; new cuts appearing; or cuts going unchanged.

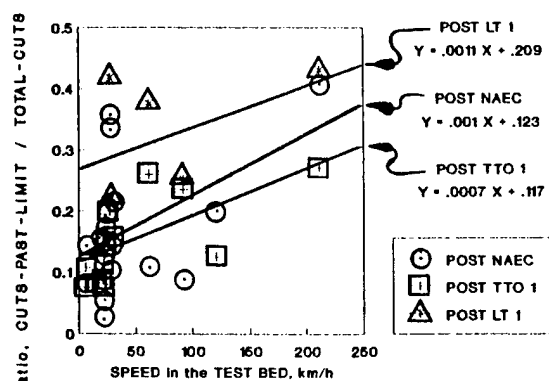
FIGURE 20: PAST LIMIT TIRE PERFORMANCE
New Tires

The ratio of cuts deeper than the Cut Limit, to the total number of cuts is presented in Figure 20. All three curves have a positive slope. The amount of damage is higher for the new tires than with the recapped tires, but the performance trend is reversed: POST TTO 1 data is below POST NAEC data. In a number of tires, the number of cuts dropped between NAEC measurements and POST TTO 1 measurements.

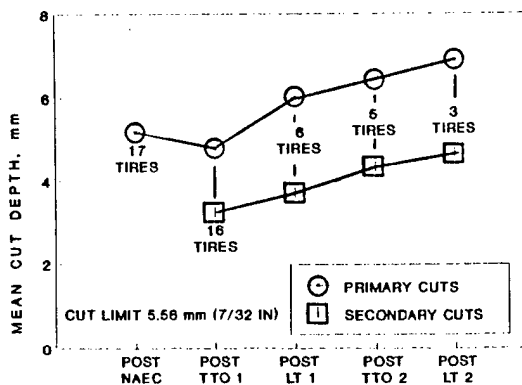
FIGURE 24: MEAN CUT DEPTH
New Tires

The mean cut depth of primary and secondary cuts of all tires is presented in Figure 24 and Table 5. The new tire trend is more severe than it was for the recapped tires: the mean cut depth increased above the Cut Limit with dynamometer tests. The data pool shrank as the test continued because of tire failures or removals after three TTO and LT segments had been completed.

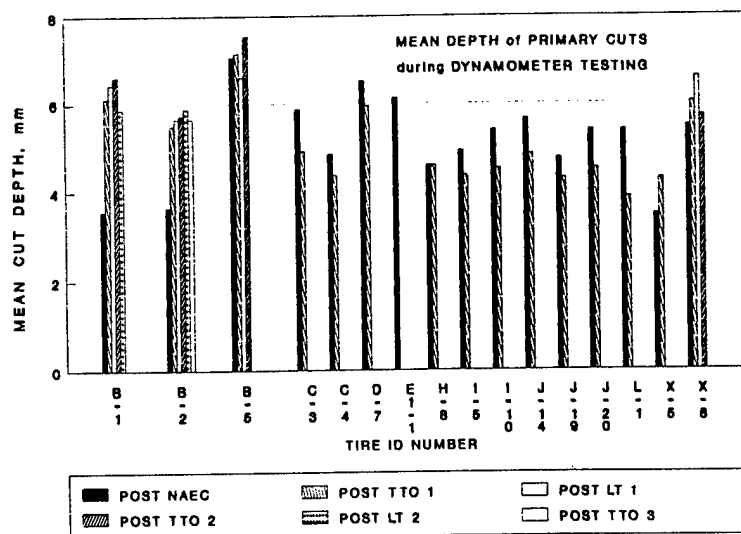
FIGURE 25: DEPTH CHANGES during TEST
New Tires

INDIVIDUAL CONDITION WITH TESTING - Changes in the mean cut depth of primary cuts of seventeen new tires are presented in Figure 25. No rational pattern can be drawn from this data. The same was true of the recapped tires.

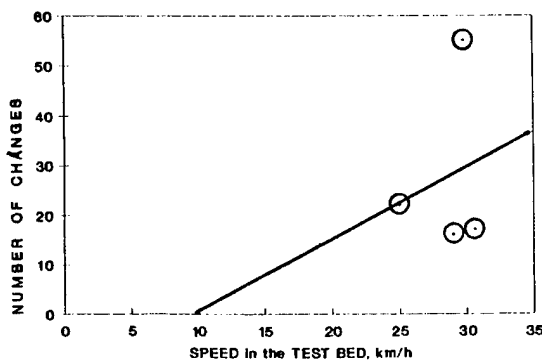
FIGURE 26: SPEED vs NUMBER of CUTS
Radial Tires

The number of primary cuts produced is presented in Figure 26, as a function of speed in the test bed at NAEC. The "newer" design H-1, 2, and 3 produced 2/3's fewer cuts than the "earlier" design H-4. Of the 110 primary cuts on all four tires POST NAEC, one half of the cuts were on H-4. Because of the small number of tires, run in a small speed range, there is not enough data to draw a useful conclusion.

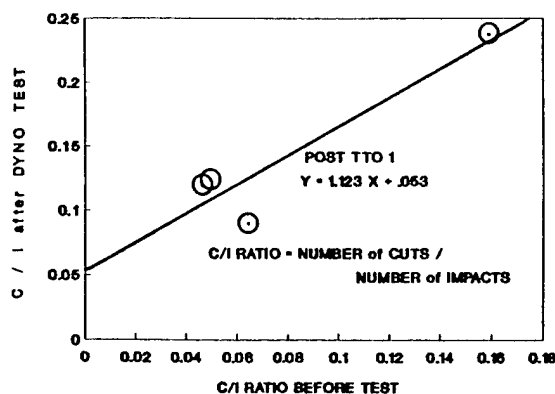
FIGURE 29: PERCENTAGE INCREASE IN CUTS
Radial Tires

In Figure 29, the data from Figure 28 is presented in a ratio of cuts per impact form. An increase of 18% is suggested. This is higher than the recaps, but lower than the new tires.

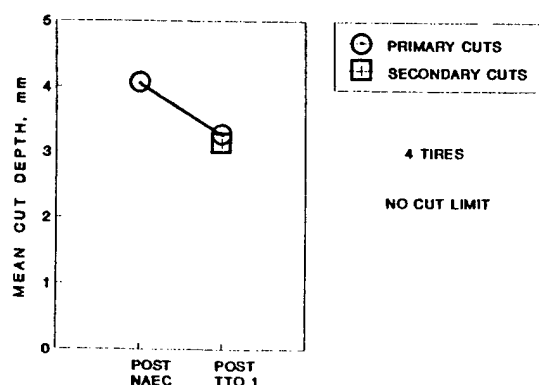
FIGURE 30: MEAN CUT DEPTH
Radial Tires

The mean depth of primary and secondary cuts of all tires is presented in Figure 30. The data population is very small, and no useful conclusions may be drawn.

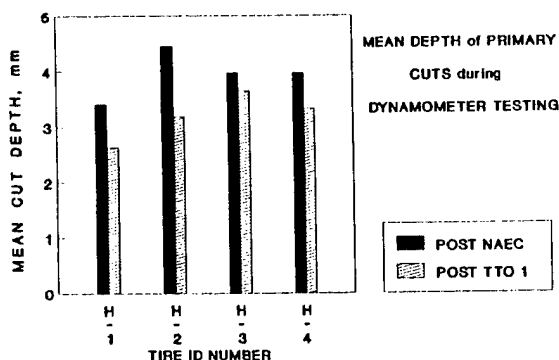
FIGURE 31: DEPTH CHANGES during TEST
Radial Tires

INDIVIDUAL CONDITION WITH TESTING - Changes in the mean depth of primary cuts of the four tires are presented in Figure 31, as each tire was tested on the dynamometer. All four experienced a reduction of depth with testing. No further maps were made after TTO 1, so no other data is available.
